THE MIAMI CONSERVANCY BULLETIN

JUNE 1920

PUBLISHED BY THE MIAMI CONSERVANCY DISTRICT
DAYTON, OHIO

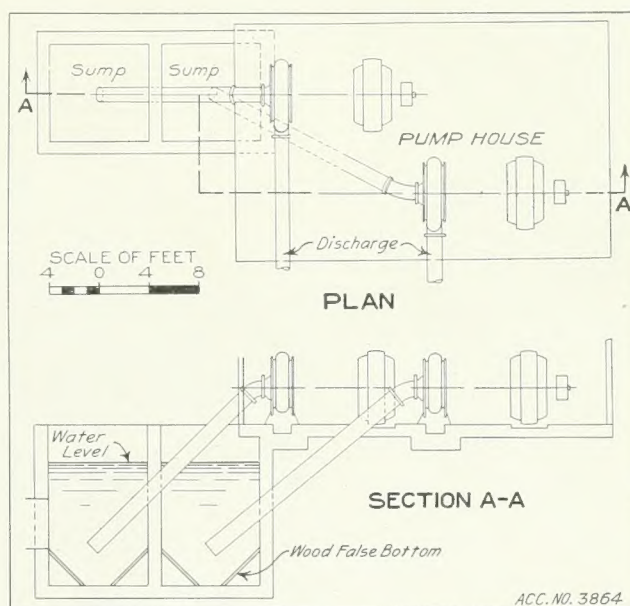
FIG. 139—FIRST SUMP LAYOUT, ENGLEWOOD.

In the first place the sump, or intake well, was not well adapted for passing the material to the suction pipe of the pump. The gravel, sand and clay fell into an inert mass at the bottom of the well and had to be sucked up by the water entering the suction. The materials had a habit of piling up until the mass became so great that a large portion of it

Then again the suction was not efficient. The pumps in Sump No. 1 had suction lengths of 18 feet and the center of the suction as it entered the pump was 7 ft. above the water level in the sump. The pump, while operating, showed 16 inches of vacuum, equivalent to 18 ft. of head. The loss of head in the suction pipe was, therefore, about 11 feet. This was due in part to velocity head, and in part to the friction in the pipe, due to its length and curvature and to the shape of its intake end. The net result of this type of sump well and of suction pipe was that unnecessary power was used, progress was limited and plugs in the pipe line were not infrequent. The latter were a particular annoyance, necessitating, as they did, an entire shut-down of the hydraulic fill operations while the pipe line was disconnected and cleared, an operation frequently involving several hours.

Another objection to the first installation was the necessity of priming the pump before starting again, after every shut-down. While ordinarily this was not a difficult operation, occasionally sand would collect in the injector, which would have to be cleaned out. In the aggregate, delays from priming amounted to a considerable loss of time.

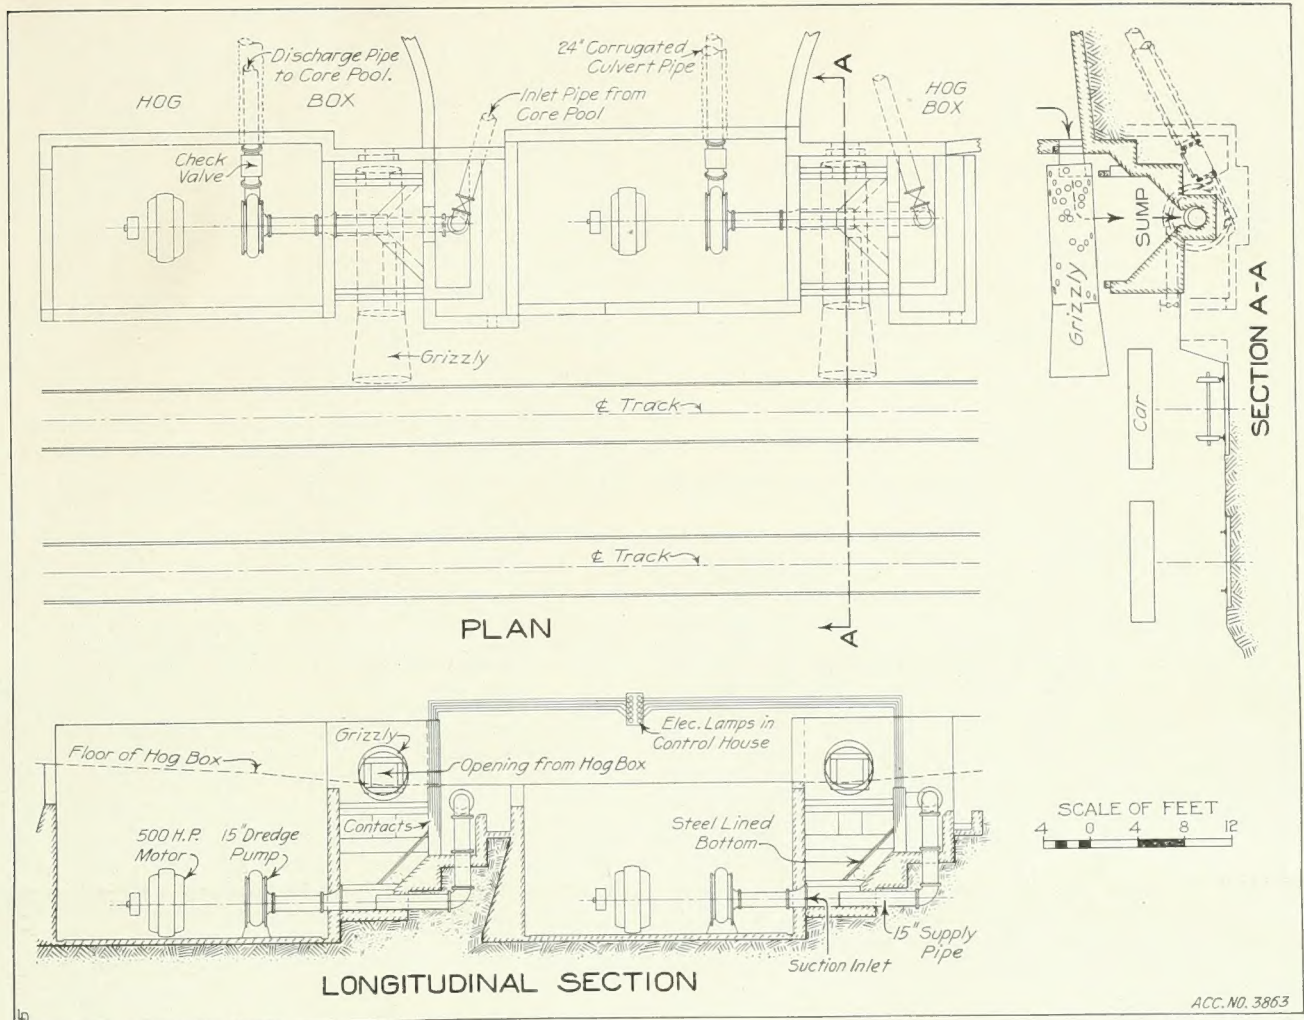
FIG. 141—IMPROVED DREDGE PUMP LAYOUT AT ENGLEWOOD DAM.

The position of the dredge pumps was also changed in the later installations. In the original layout the pumps were set 7 feet above the water level in the sump and had suctions 18 ft. long. In the new layout the pump was set 8 ft. below water level. The result is that the pump is always primed ready for operation. The pump suction pipe is straight and horizontal, 5 feet, 6 inches long. At

the sump end the entrance to it is given a bellmouth shape to eliminate contraction of the entering jet. The supply pipe bringing the return water from the core pool (the circulation in the pumping layout being a closed system, pumps to pool and back again), is in a direct line with the pump suction. Thus the flow is straight from the return supply into the pump suction. Between the two is a short open topped conduit in line with both, into which the material from the hog box is dropped, as detailed in the next paragraph. Loss of energy at the pump suction is by these means materially reduced, tests showing a loss of head of about 3 feet as against 11 feet in the old sump, a saving of 8 feet. Stated otherwise, and applied to our particular problem here, this means that the millions of cubic yards of mixture of earth materials and water remaining to be pumped will require to be pumped through 8 feet less height.

In the old layout the discharge pipe left the pump horizontally, necessitating a bend up the slope of the dam. In the new design the pump was set at an angle of 27 degrees with the horizontal, enabling the discharge pipe to be laid without bends. In this arrangement of suction and discharge the only deviation from a straight line occurring in the course of the pumped material from the sump up to the side of the dam takes place in the pump itself, incidental to the centrifugal pumping operation, consequently frictional resistances and wear are reduced to a minimum.

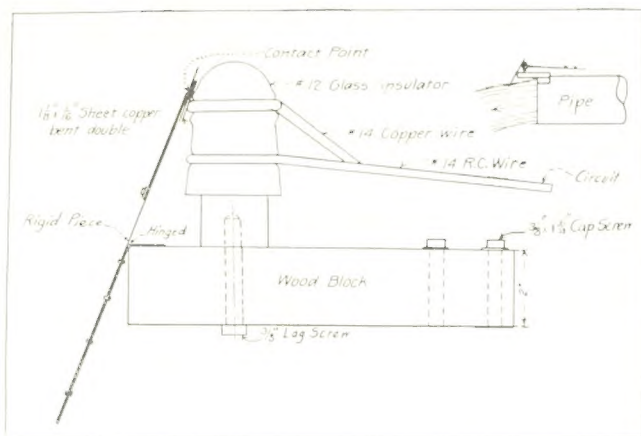
FIG. 142—ELECTRICAL INDICATOR FOR DREDGE PIPE.

Diagrammatic sketch of its attachment to the pipe, but not showing the clamps, is shown in the upper right-hand corner. See also Fig. 140, where the device appears turned end for end as compared with this cut. The wood block above is screwed to an iron plate bent to the curve of the pipe end and clamping to it as in Fig. 140. The working piece is the thin diagonal metal plate at the left, hinged to the top edge of the block. The lower part of this dips into the stream discharging from the pipe, as shown in the upper right-hand corner. The force of the stream keeps the upper part of the hinged plate in electrical contact with a metal point attached to the glass insulator. When the discharge slackens the lower part of the plate drops by its own weight and the contact is broken. An electric lamp in the pump house, which is in the electrical circuit, then goes out, warning the pump man that the discharge has slackened to the danger point, indicating an incipient "plug" or stoppage of the dredge pipe by the suspended earth materials which it carries. The pump man then throws more power into his dredge pump motor, breaking up the incipient plug and driving it on to the discharge outlet. This device worked well, but did not indicate how near the critical point of "plugging" had been reached. See page 167. The new system, there described, corrects these shortcomings.

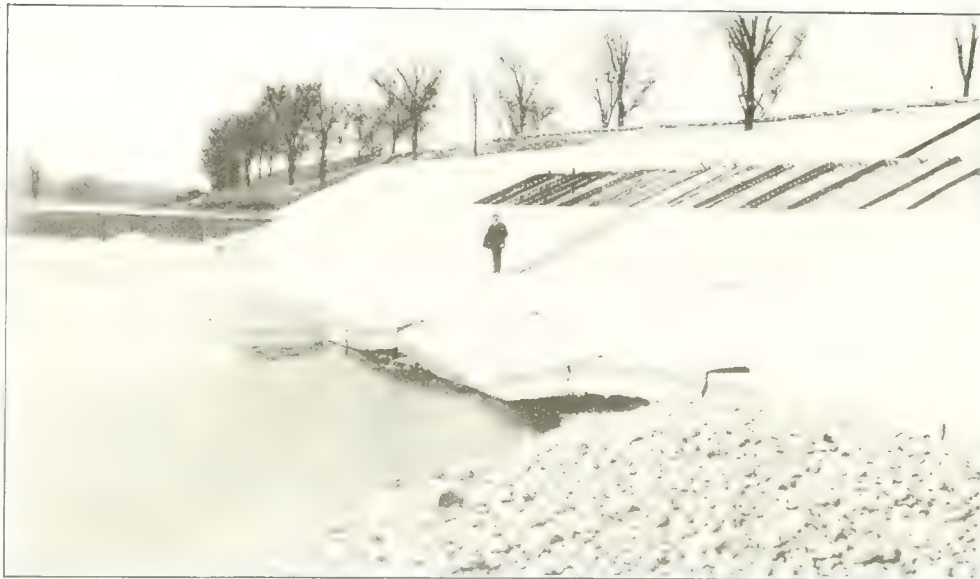
FIG. 144—THE FLEXIBLE REVETMENT IN ACTION. MARCH 25, 1920.

In flood seasons, such a surface of concrete protects the earth under it, but along the river edge, the scouring action of a swift current tends to undermine it. When this happens, the fabric, being flexible, simply drops to cover the shore side of the excavation made by the current, and thus protect it from further direct action. The result is seen in Fig. 144 and Fig. 145.

The action indicated in these pictures took place at a particularly vulnerable place, just below the Island Park dam, in Dayton. At its east end, this dam abuts upon the levee some distance up the slab slope, as shown in the pictures. The dam crest being level, the result is that at all stages of the river, water at the east end of the dam is pouring in a sheet, thicker or thinner, upon the levee slabs, thence down their slope and across the flexible floor, which also has a slight slope, till it reaches the unprotected river bed, at the lower edge of the mattress. In its rush down the levee slope, it acquires high speed, and strikes the unprotected river gravel like a liquid excavator, or modified "hydraulic monitor," excavating a channel for itself along the edge of the re-

The action of the Island Park dam, seen in the distance at the left, makes this a peculiarly vulnerable place. The water pouring over the end of the dam upon the slab slope, rushes down the latter at high speed, and across the flexible mattress till it strikes the exposed gravel of the channel at the mattress edge, acting upon it as a powerful liquid excavator, undermining the mattress till the latter sinks under the water surface. The channel seen here next the mattress was thus formed, until it attained sufficient depth to protect the

gravel bottom against further erosion by forming a liquid cushion to take the impact of the water rushing down the slope. The flexible mattress sank here a maximum of seven feet below its original position, its steel cables keeping its structure intact, to a new position where it now protects the shore slope of the eroded channel from further scouring action. The "hump" in the foreground is caused by heavy boulders which protected the gravel at that point from erosion. It illustrates the flexibility of the mattress in adapting itself to an uneven bottom. This picture was taken before the flood of April 20. Fig. 145 shows what the flood did to the revetment.

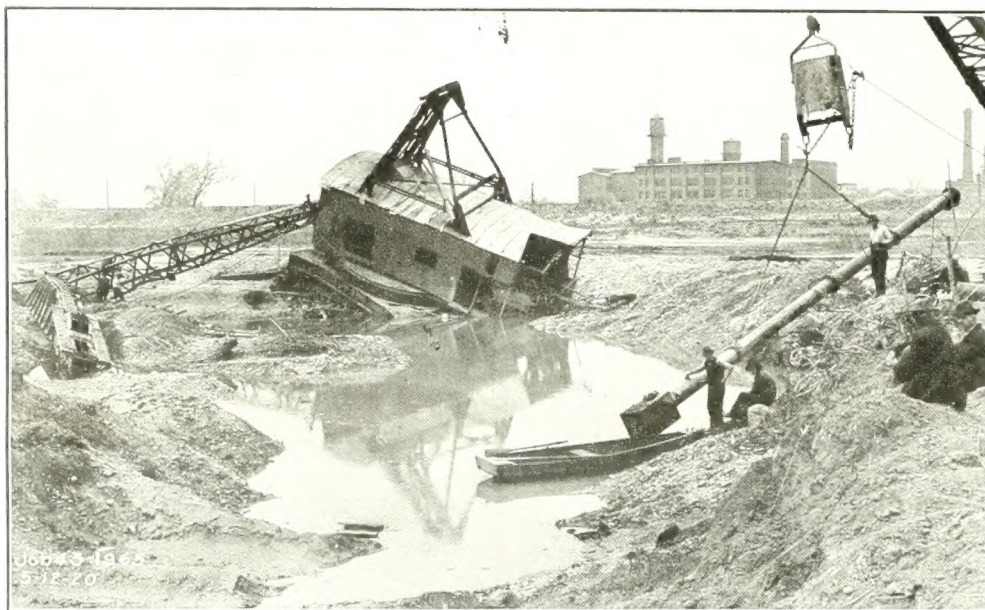
FIG. 146—WRECKED DAYTON DRAGLINE EXCAVATOR, MAY 12, 1920.

it, leaving it as seen in Fig. 146. About fifty tons of counterweight load the rear end of the frame, to balance the overhang of the boom. Several tons of this counterweight are excess, to balance the pull of the hoist cable, and it is probable that it was the throwing of this excess counterweight into unstable equilibrium as the revolving frame canted under the wash of the current, and its quickening swing to regain equilibrium after passing its high point, that caused the peculiar wrecking of the boom. The position of the wrecked parts indicates this, since the rear (counterweight) end of the frame, which before the flood was downstream, is seen in both pictures pointing upstream, and the wrecked boom, which was pointed upstream, clearly swung downstream and inshore, and apparently broke when the end struck the river bottom. The energy of 80 to 85 tons of metal, revolving on a wide arc, is the only available force which would seem adequate to account for the peculiar damage to the boom.

bank of the river. In both pictures parts of a smaller dragline appear used in the work. The wrecked dragline is seen enclosed by an embankment of earth built around it from the east bank by the smaller machine. The water in the enclosure was then pumped out, the pipe at the right in Fig. 146, hanging by chains, being the suction pipe of the centrifugal pump which did this work. The chains hang from the dragline bucket, the small machine acting as a wrecking crane as well as an excavator. In Fig. 147 the little machine is removing the pieces of the wrecked boom, which were taken to the Conservancy shop on 7-ton trucks, and there repaired. The wrecked dragline was righted by digging away the river bed from beneath the high corner (using the small excavator for this purpose), and then building up under the low corner with timber work as seen in Fig. 147, the lifting being done by powerful jacks.

The fifty tons of counterweight were, of course, removed before the raising, and replaced after the wheel trucks on which the machine rolls were once more in position on their rails and "mats." The chief injury, next to the broken boom, was the breakage of the large propelling shaft under the middle of the revolving frame. A spare shaft was in readiness, so that there was no delay on this account. The electric motors, which supply all motive power, were under water during the flood. They were wiped clean, and dried by running a low voltage current through the coils, the heat generated by the current being quite sufficient for this purpose. The connections for accomplishing this, which may interest the electrical fraternity, are given in the editorial column.

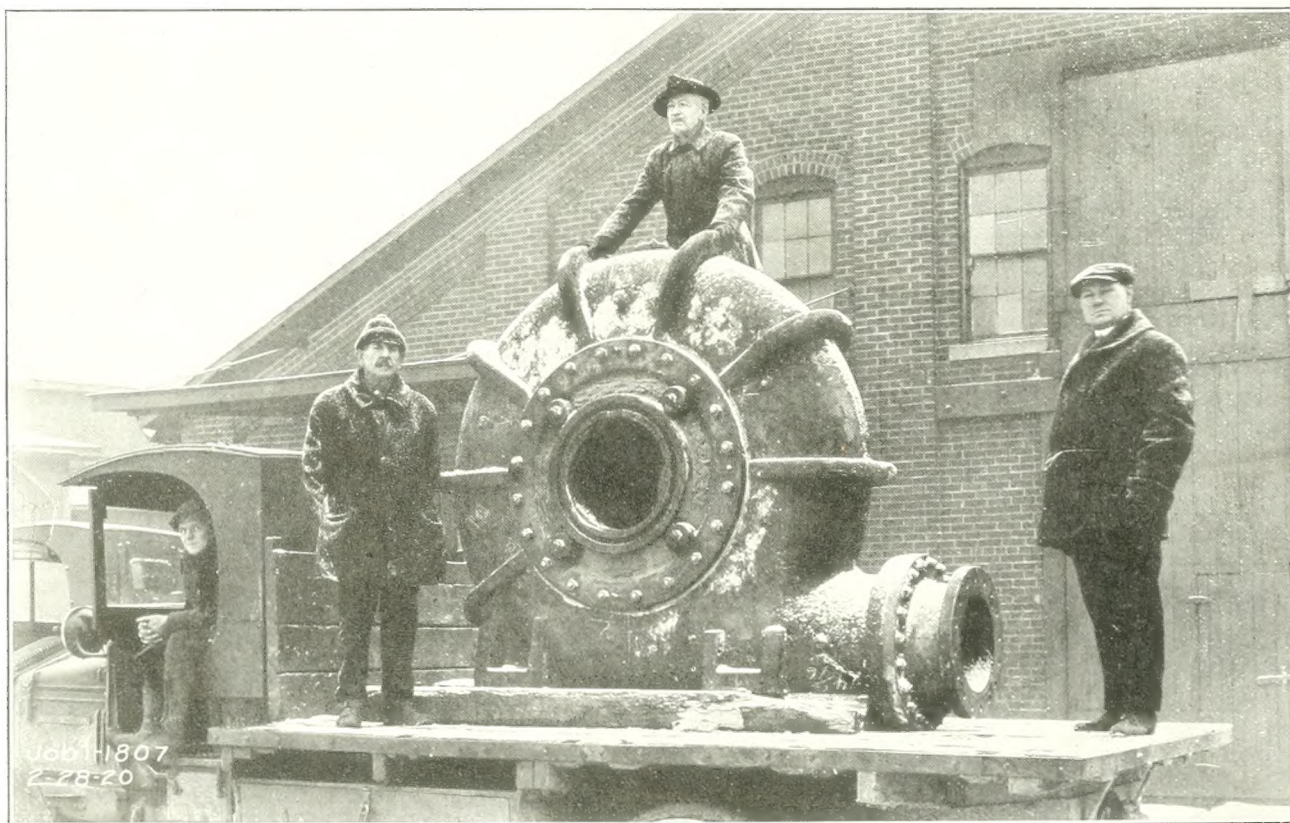
FIG. 150—HEAVY WHITE IRON CENTRIFUGAL PUMP SHELL. FEBRUARY 28, 1920.

The first pumps used on the Conservancy work were of cast iron, and showed rapid wear, the pump shell going on the scrap heap after pumping some 160,000 cubic yards of earth. Manganese steel gave improved service, the life of this material in the Englewood dredge pump shells being from 134,000 to 182,000 cubic yards of gritty material pumped. The metal being rather expensive—26 to 27 cents per pound—Mr. Fowler S. Smith, the District's Purchasing Agent, suggested the use of white iron, which is very much cheaper, is at the same time exceedingly hard, and on account of less contraction, can be cast in thicker sections than manganese steel. It seemed to him also that the ability to get replacements of parts in Dayton, where certain firms specialize in white iron castings, would again effect a large saving in shipping charges and expense due to shipping delays. Mr. A. S. Robinson, the District's Mechanical Engineer, and Mr. William McIntosh, its Master Mechanic, had been planning at the same time an improved design giving added life by increasing the shell thickness beyond that possible when manganese steel is used.

The first of the resulting pump shells is shown in the figure. The weight of the ribs and flanges may appear excessive in places, but was necessary in order to avoid shrinkage stresses in cooling, which might result in weakness and breakage. The thickness of the shell varies somewhat, being greatest at the rim, where the wear is a maximum, and least on the faces. Imagining the shell seen as a clock face, the extreme thickness, at "6 o'clock," is $5\frac{1}{4}$ inches. At 8 o'clock it is 5 inches; at 10 o'clock, $4\frac{1}{2}$ inches; at 2 o'clock about 4 inches. On the faces it is about $1\frac{1}{2}$ inches. The pump is a 15-inch pump, absorbing at maximum head 500 horse power and capable of pumping 7,000 gallons per minute at 150 feet maximum head. The flange on the near face is a separate piece, bolted on. The shell proper is machined in only four places—being faced in a lathe on its two faces (to receive the face flanges), on its top (to receive a priming connection) and at the outlet flange face as seen below at the right. (In the picture a reducer connection is shown bolted to the flange.)

The performance of the pump shell to date has been highly satisfactory to those concerned. The pump is installed at the Germantown dam, where it acts as a "booster" in the regular dredge pipe line to the dam top, now 60 feet above the old creek bed. In this capacity, where the wear should be about the same as in the lower pump, it has pumped to date 110,000 cubic yards, wearing away in the performance $\frac{1}{4}$ inch of shell. Taking into account that the skin of the casting is likely to be somewhat harder than its interior, the builders estimate a probable total pumping duty of about 400,000 cubic yards. This should be contrasted with the 160,000 cubic yards of the gray cast iron shell at Taylorsville dam, and with the 134,000 to 182,000 cubic yards of the manganese steel shells at Englewood. The manganese steel shell at "6 o'clock" was orig-
